# Manhole Inspection Summary

Manhole # S15I\_\_011MH

Insp Date: **8/3/09 11:32 AM**

**Location** Address: **2876 W. BALTIMORE ST** Cross Street: **ELLCOTT DRIVEWAY**

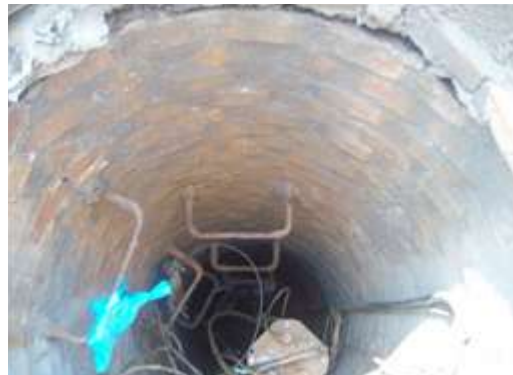
Defect 1

**Steps** Count: **18** Missing: **2** ☒ **Corroded**

CORRODED STEPS

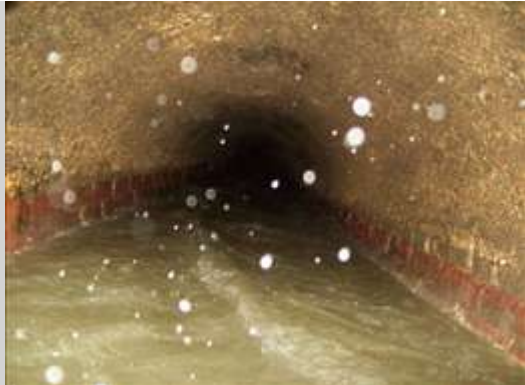
12 O'Clock Outflow

33 in. Circular Gravity Sewer  
Pipe Out @ 12 O'Clock

Pipe Height: (in.) Direct  
Pipe Material: **Concrete** ☐ Pipe Lined  
Invert Depth: **24.11** (ft.) Flow Characteristics: **Fast**  
Deposits: ☒ None ☐ Mud ☐ Sludge ☐ Debris ☐ Grease  
Silt Depth: (in.) Deposits Extent:  
Infiltration: **None** Pipe Seal Cond: **Sound**

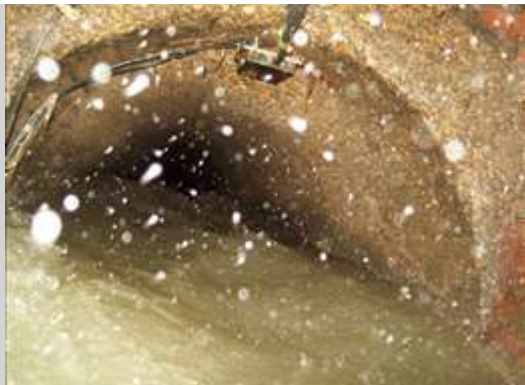
6 O'Clock Inflow

33 in. Circular Gravity Sewer  
Pipe In @ 6 O'Clock

Pipe Height: (in.) Direct  
Pipe Material: **Concrete** ☐ Pipe Lined  
Invert Depth: **24.10** (ft.) Flow Characteristics: **Fast**  
Deposits: ☒ None ☐ Mud ☐ Sludge ☐ Debris ☐ Grease  
Silt Depth: (in.) Deposits Extent:  
Infiltration: **None** Pipe Seal Cond: **Sound**

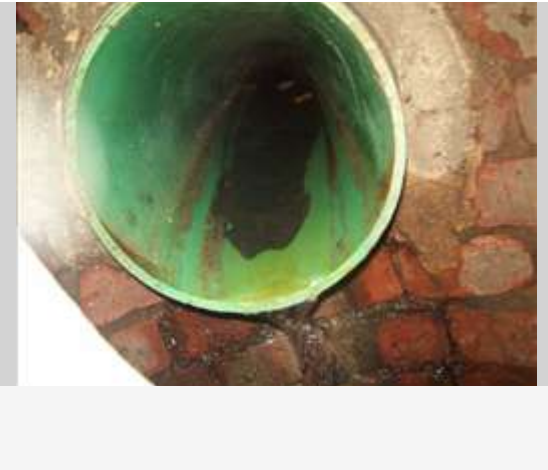
9 O'Clock Inflow

8 in. Circular Gravity Sewer

Pipe In @ 9 O'Clock

Pipe Material: **PVC** ☐ Pipe Lined

Invert Depth: **7.50** (ft.) Flow Characteristics: **Slow**

Infiltration: **None** Pipe Seal Cond: **Sound**
